Hydraulic Jacking

Best Practices in Dam and Levee Safety Risk Analysis

Part F – Hydraulic Structures

Chapter F-1

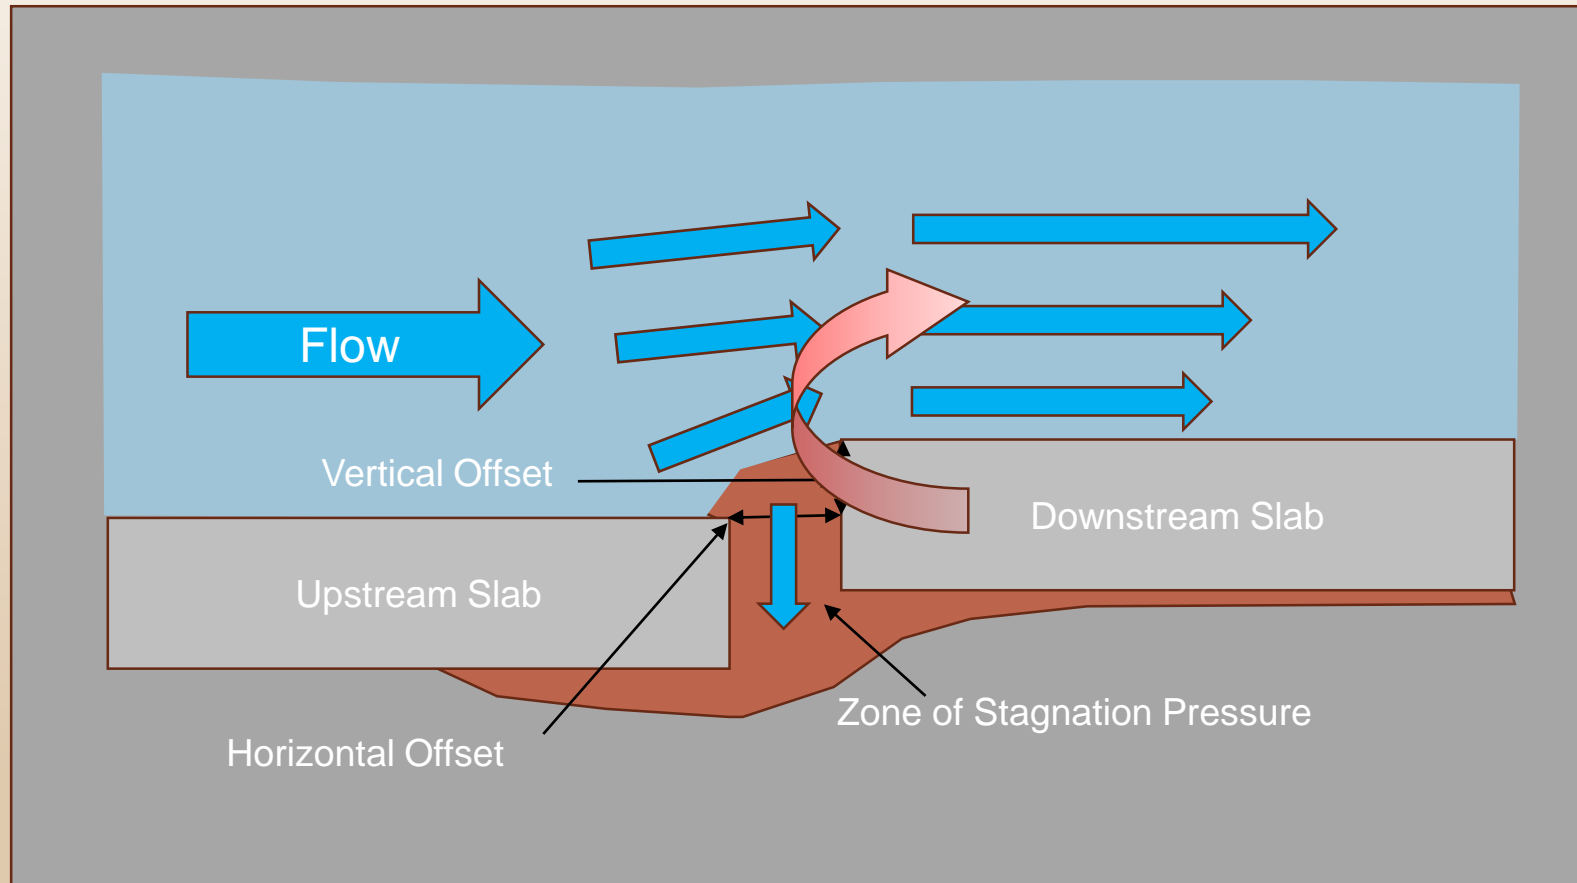
Stagnation Pressures

- Stagnation pressure enters joint and reaches foundation – High pressures/Significant flows
- Limited/Blocked Drainage Capacity
 - Pressures develop that exceed weight/anchorage
 - Hydraulic jacking removed slab
- Drainage
 - Erosion of foundation materials due to the introduction of spillway flows underneath the spillway chute
 - Collapse of structure

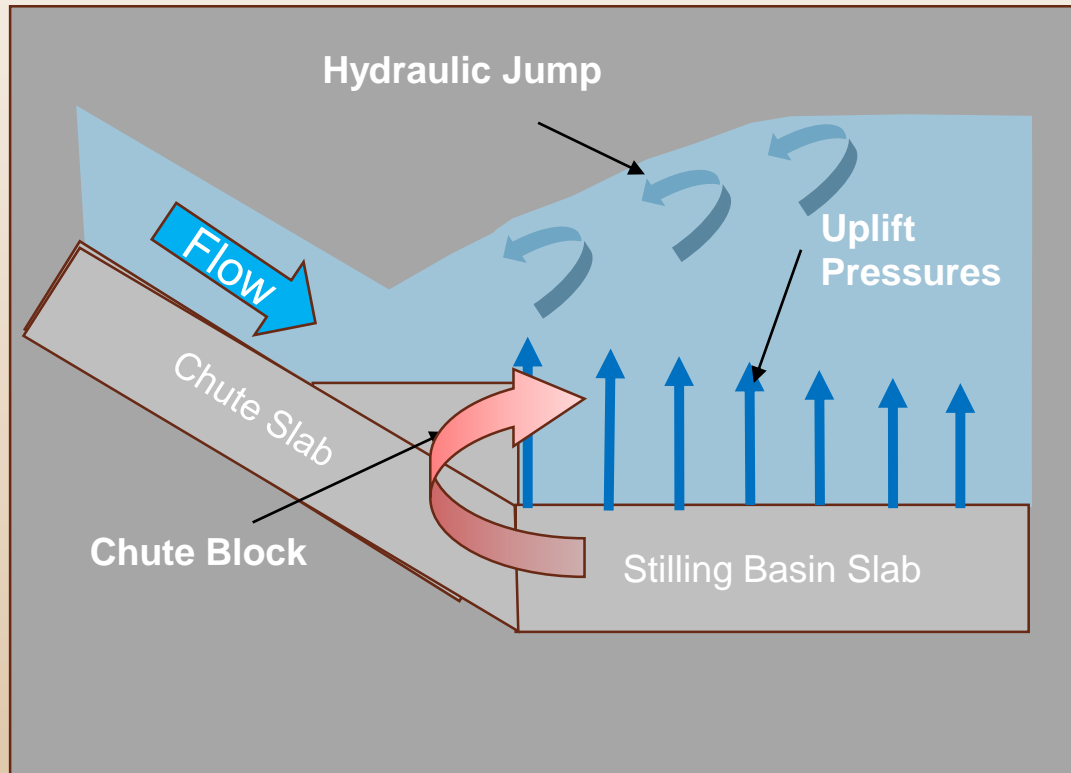
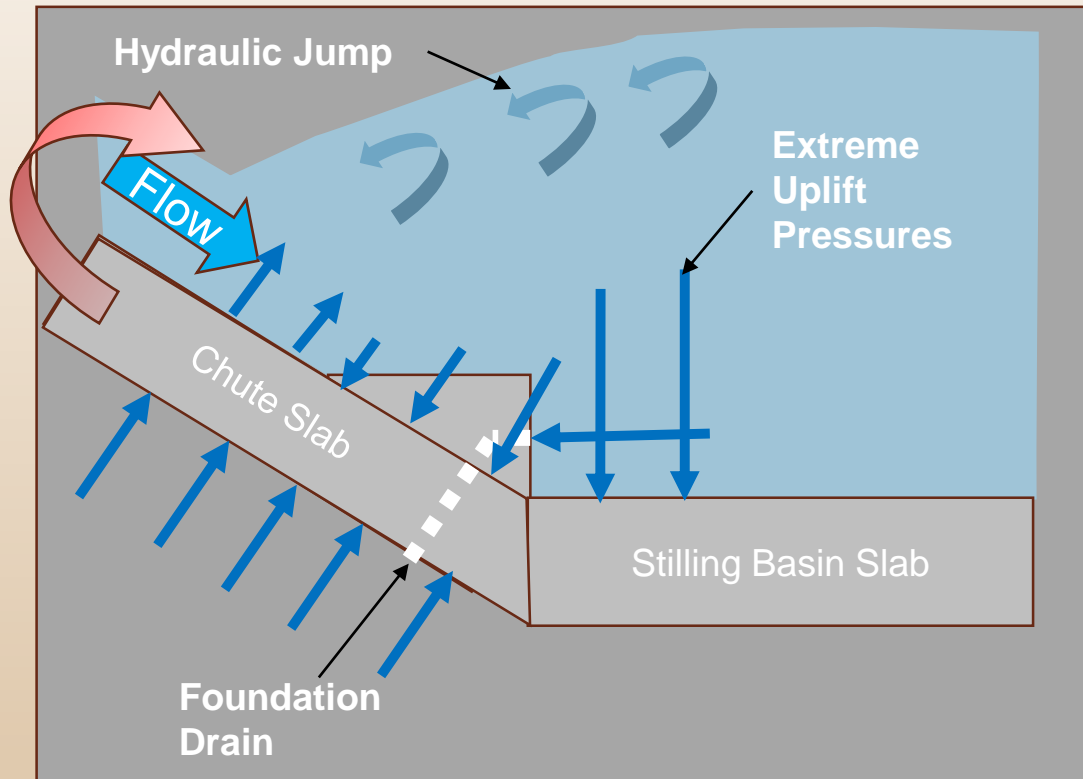
Extreme Pressure Fluctuations

- Hydraulic jump creates high pressure fluctuations that can act in different directions across the jump
- Negative pressures can occur over the slab at the same time positive pressures can charge under the open slab thru joints and foundation drains
- The location of the hydraulic jump can move with changing flow conditions and tailwater and create unexpected combinations

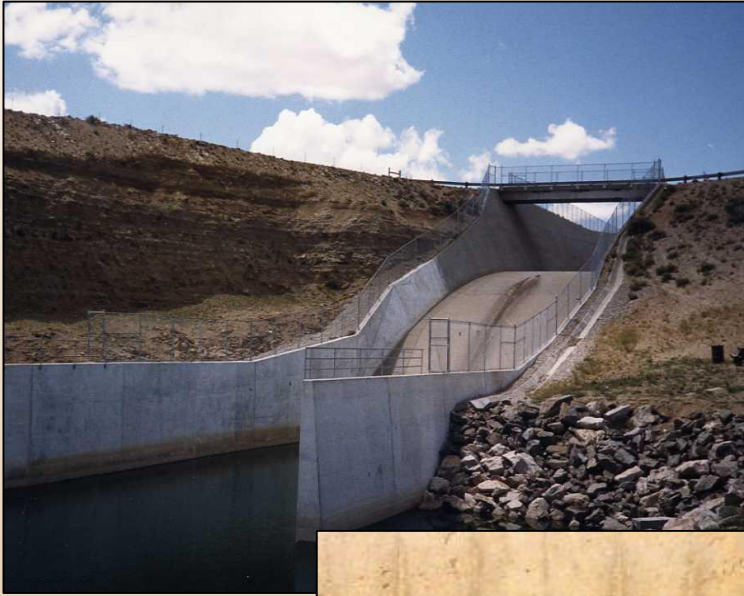
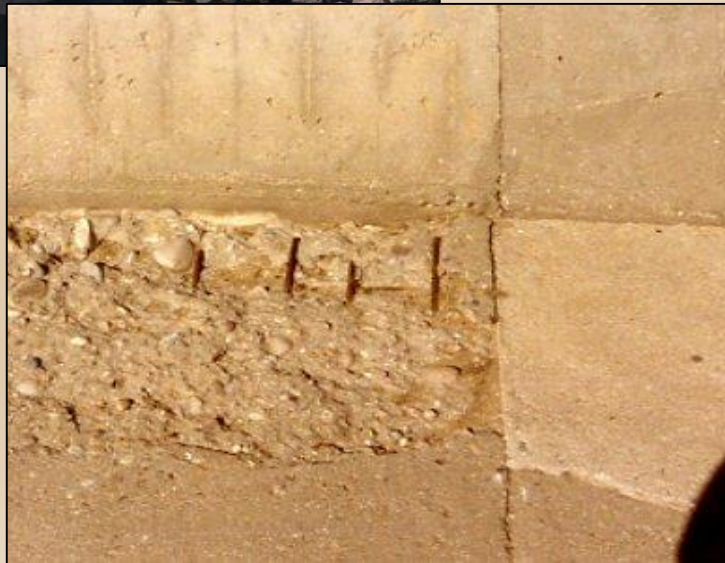
Big Sandy Dam

- USBR Dam in Wyoming
- Spillway operated without incident from 1957 to 1983
- Chute floor slab failed in June 1983 due to uplift pressures from flows of $400 \text{ ft}^3/\text{s}$
- Chute inspected after releases ended
- 15-inch thick slab was lifted 2 feet off its foundation
- Later determined that slab failed due to static and dynamic water pressures under the slab
- Offsets (vertical and horizontal openings) existed at the upstream edge of the slab allowed water to introduce flow under the slab

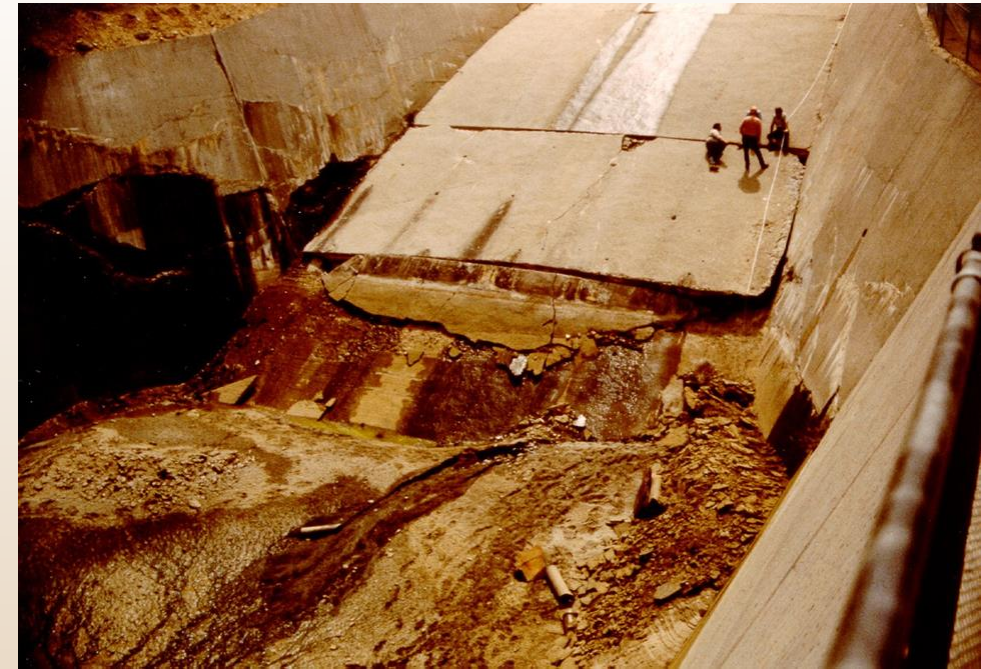
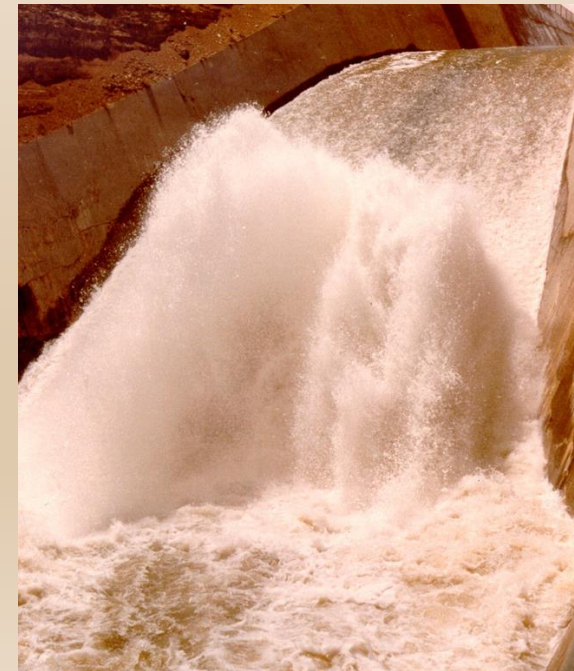
Big Sandy Dam

- Big Sandy Spillway Slab failed during spillway discharge of 400 ft³/s
- Failure was initiated by offset into flow (depth of flow – 0.3 ft; velocity – 31 ft/s)
- Assuming 1/8 inch open joint, vertical offset of 0.50 inches and anchor bars only 50 percent effective, slab would fail
- Analysis demonstrates that with anchor bars fully effective, slab would not have failed by Stagnation Alone
- From observations after failure, anchor bars exposed beneath slab were not coated with grout which suggests they were not bonded

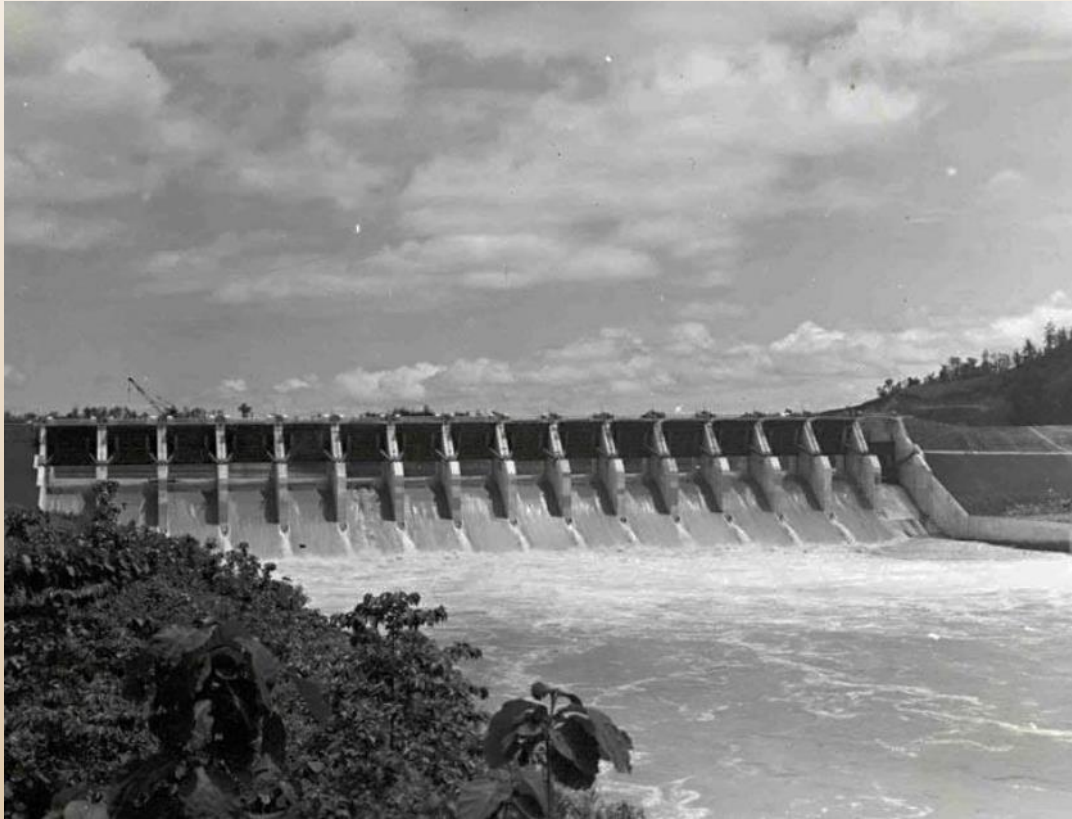
Karnafuli Case History

- Project is located in Bangladesh
- Spillway operated immediately after completion in 1961 during a Monsoon Flood
- Distressed areas were observed on August 13th; but project continued to flow until August 20th
- Inspection after the event demonstrated significant damage to the lower spillway chute slabs
- Slabs were 1.5-ft to 4-ft thick, underlain with sand and chute blocks that have foundation drain exits

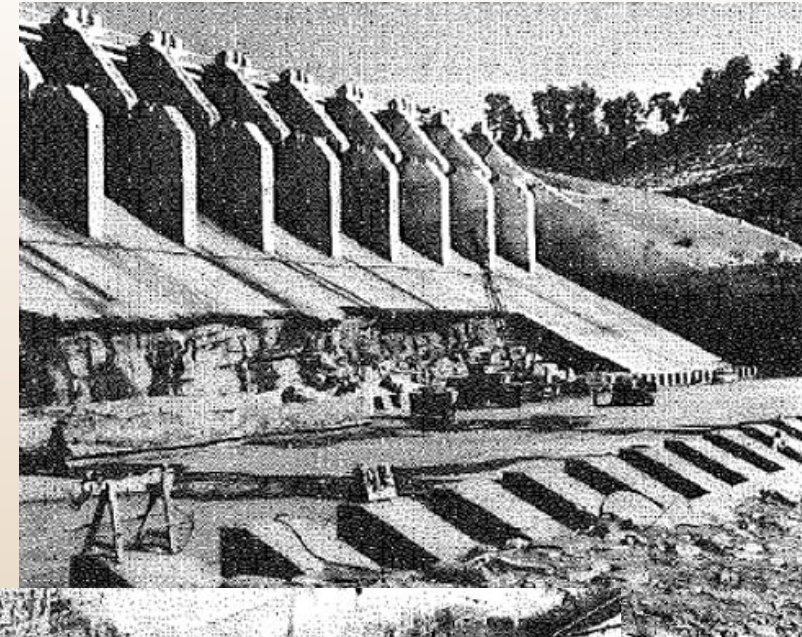
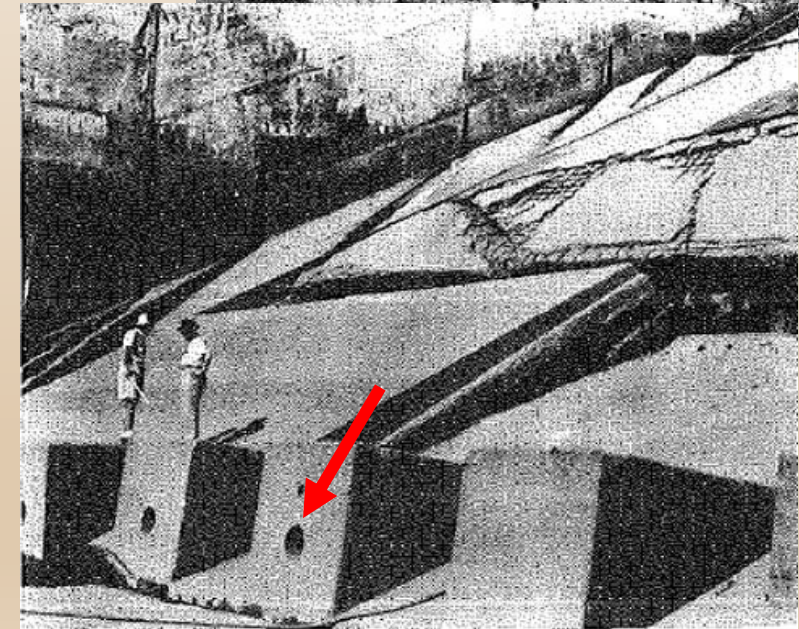
Photos from Bowers et al 1988

- There was damage to approximately 600-ft of the 745-ft wide spillway chute
- Significant erosion of exposed rock
- Board of Consultants concluded that the failure was a result of fluctuating pressure near the toe of the hydraulic jump
- Physical modeling suggests that it was likely that low pressures occurred over the slab while simultaneously positive pressures charged the foundation
- Design philosophy at the time was that the back of the Chute Block would be low pressure zone, the actual tailwater was higher than assumed for design, forcing the jump on the chute

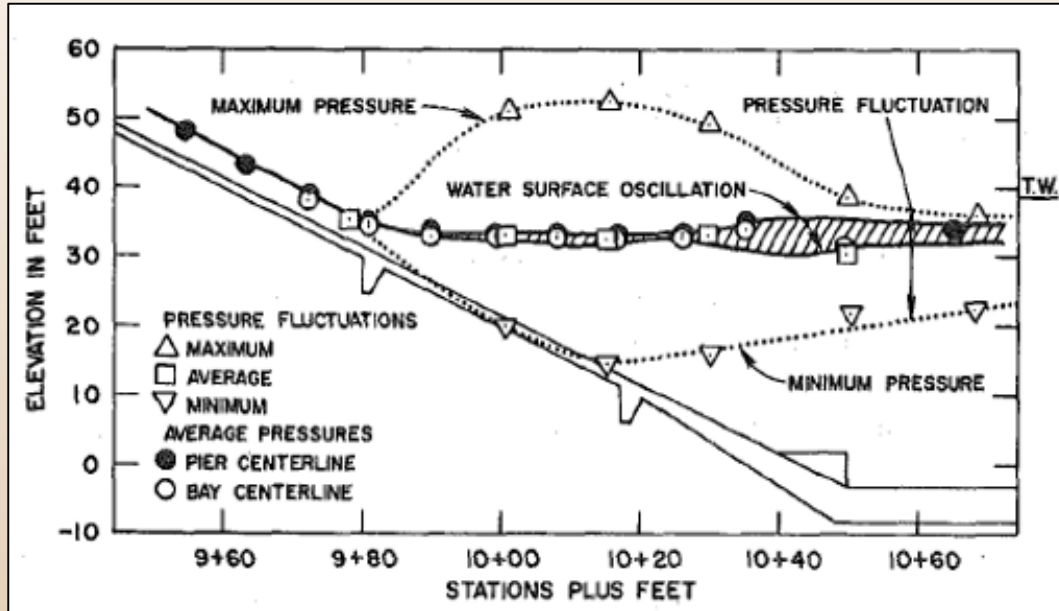
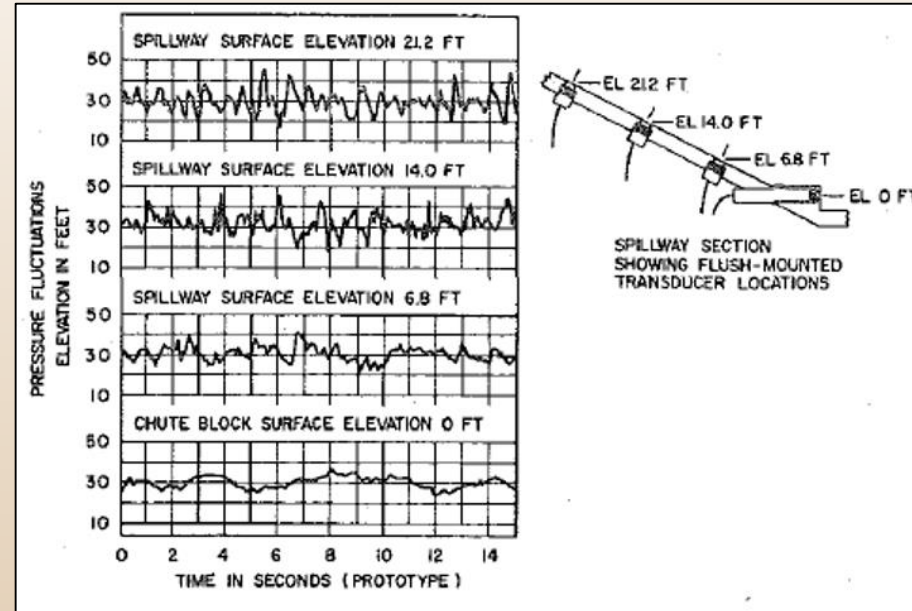
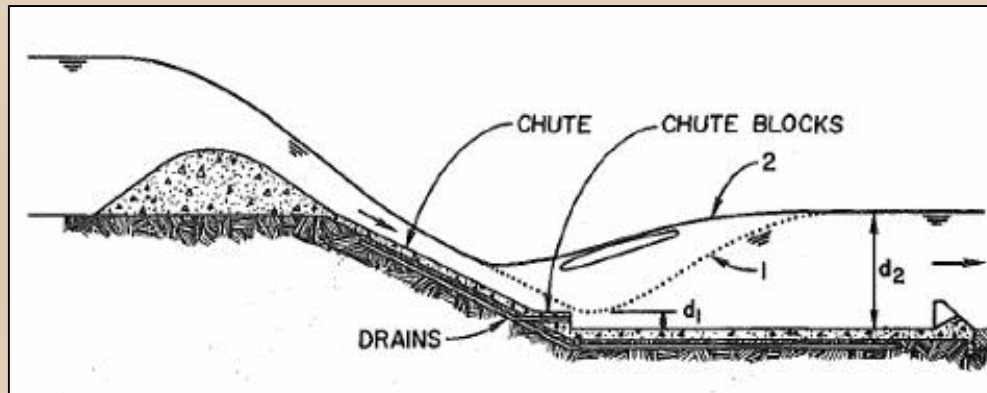
Karnafuli Case History

St Anthony Falls Hydraulic Laboratory, Project Report No. 73, Hydraulic Studies of the Spillway of the Karnafuli Hydroelectric Project East Pakistan

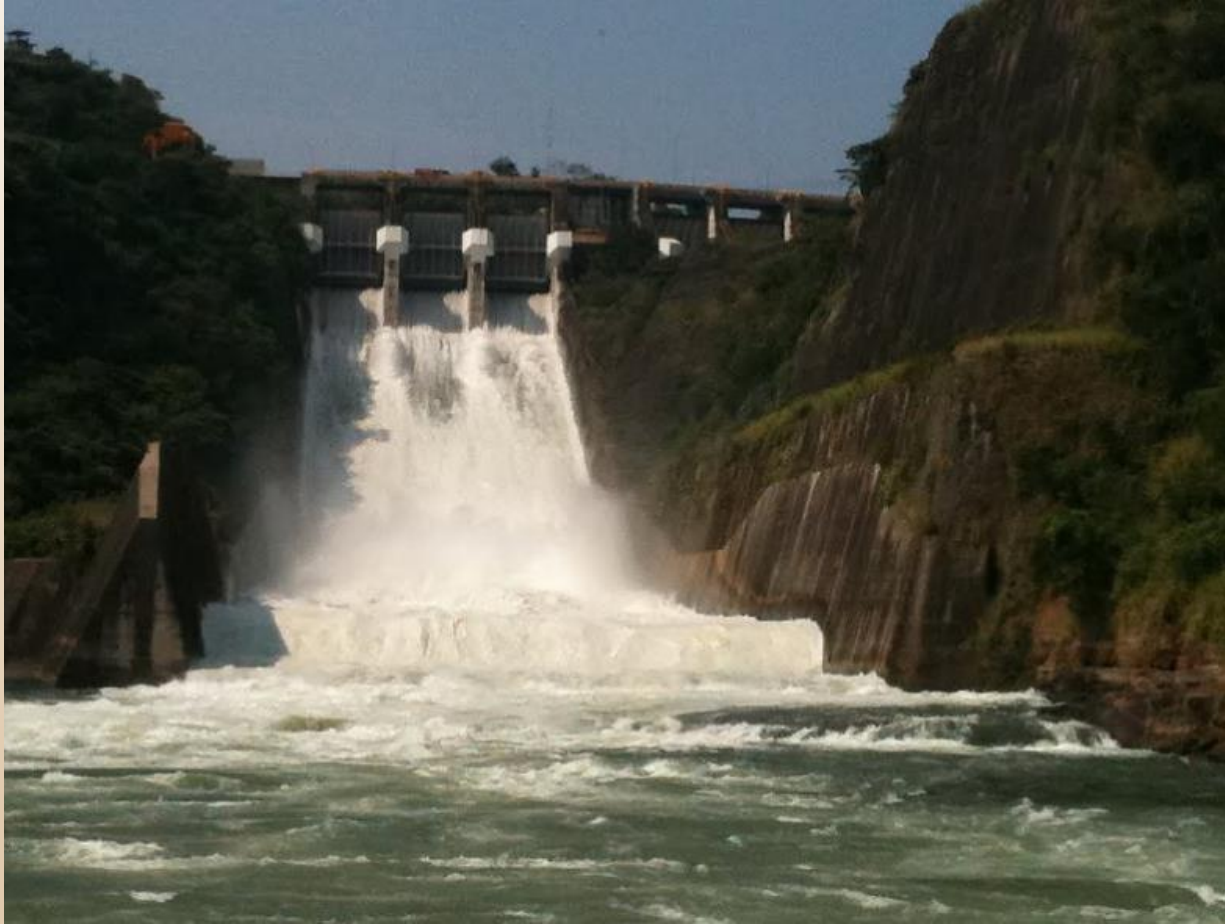
Malpaso Case History

- 450 foot high Embankment Dam in Mexico
- 8.5 million acre-feet reservoir
- 320-foot Long, 160-foot wide hydraulic jump stilling basin
- Design Discharge of 212 kcfs
- Operated for three years at flows below 88 kcfs
- Had severe stilling basin damage after a 106 kcfs flow event

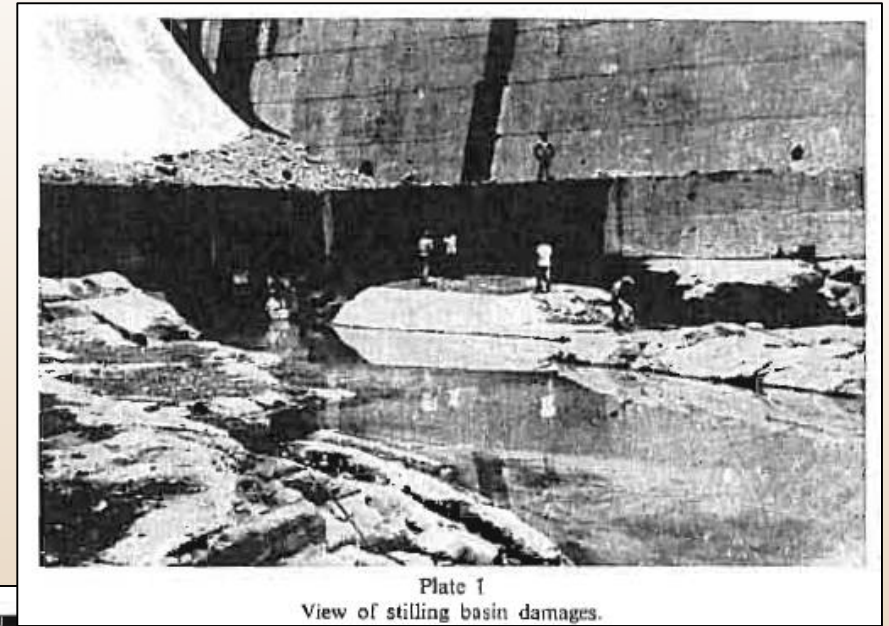
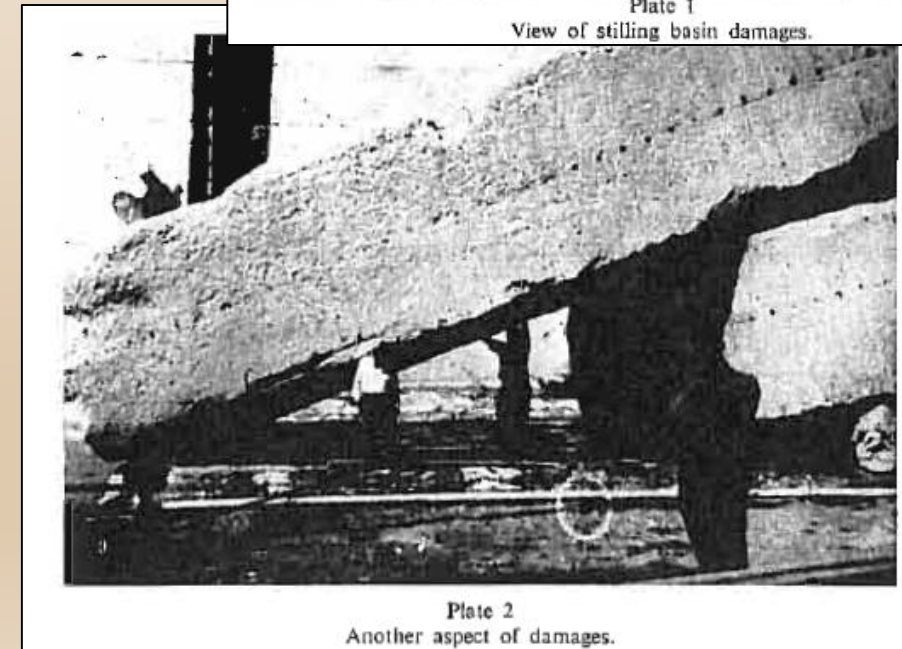
Malpasso Case History

- Multiple Slabs Failed
 - 40ft x 40ft in size
 - 6.5 ft thick
 - (12) 1 ¼ inch bars in each slab
- Slabs flipped upside down and deposited at exit channel
- Significant damage to exposed rock
- Slab failure was attributed to Hydraulic Jacking related to fluctuating Pressures

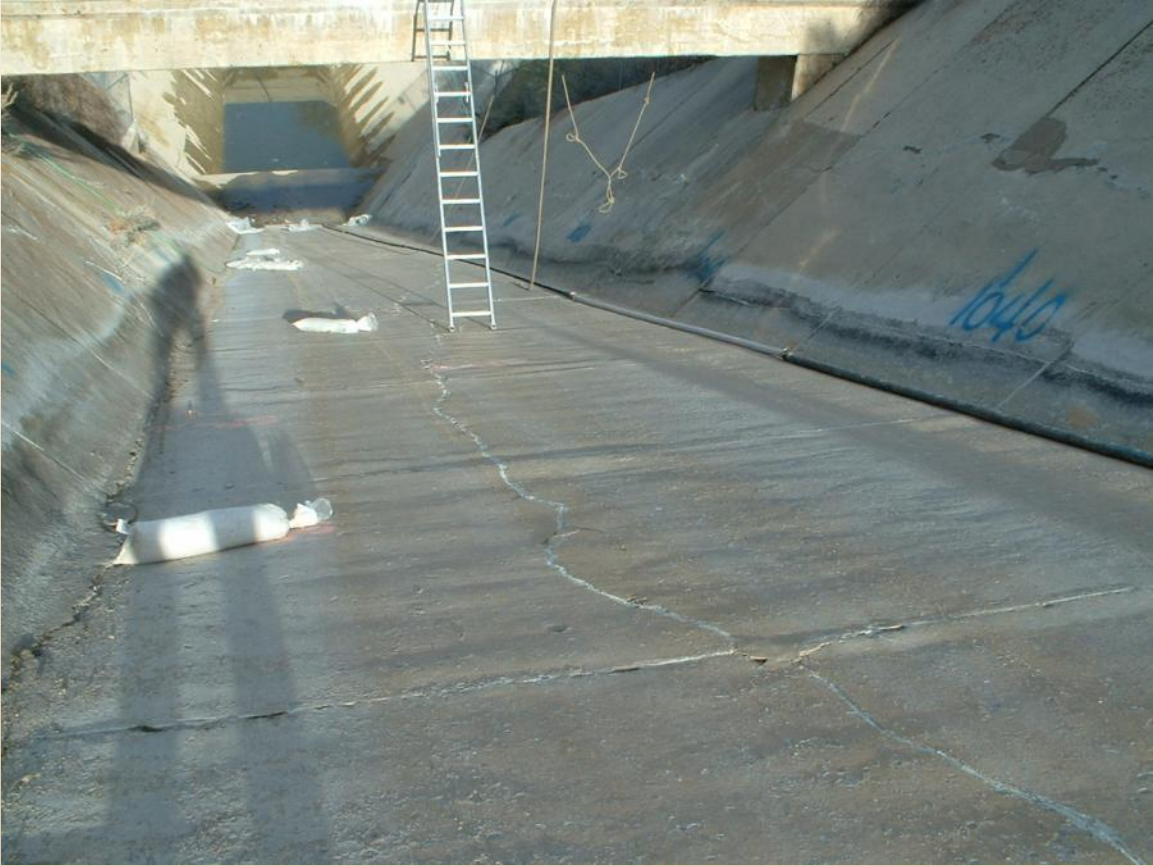
Hyrum Case History

- USBR Dam located in Utah
- 116 feet high earthfill embankment completed in 1935
- Thin concrete-lined spillway chute
- Erodible foundation soils

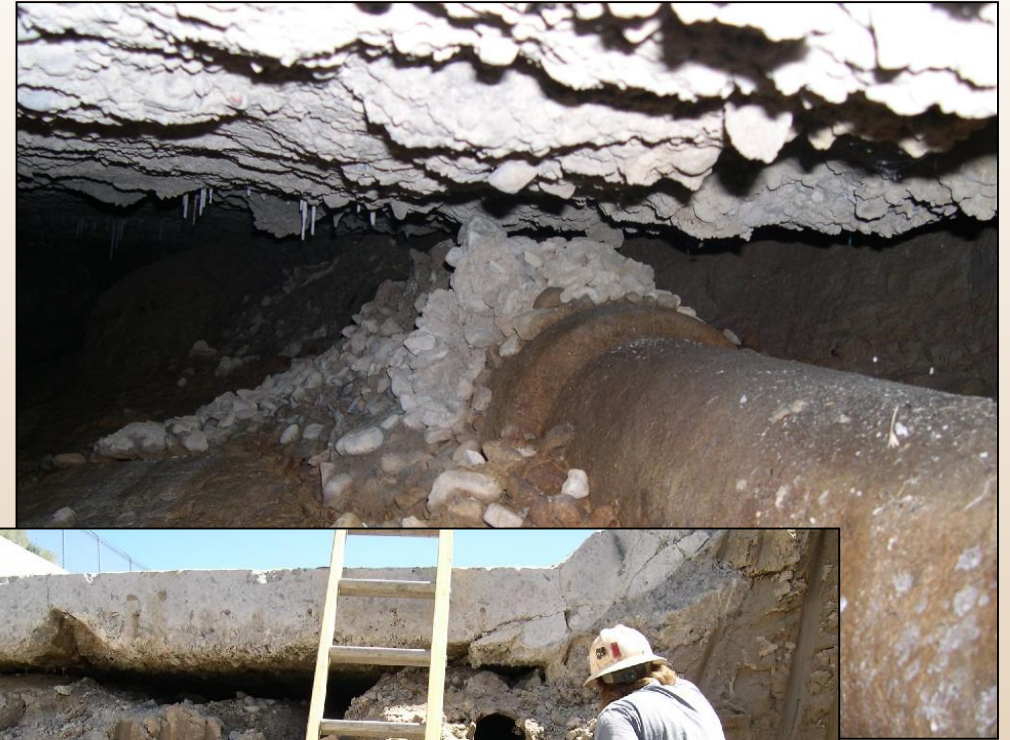
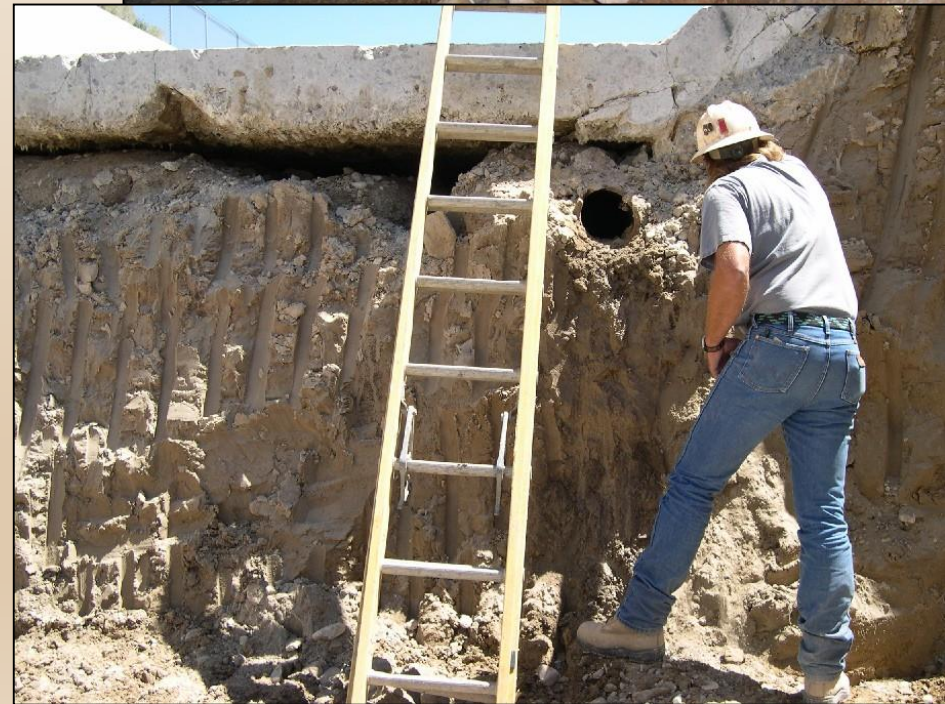
Hyrum Case History

- A continuous channel over two feet deep in places was observed
- No steel across the slab joints
- Underdrain system; but no filter

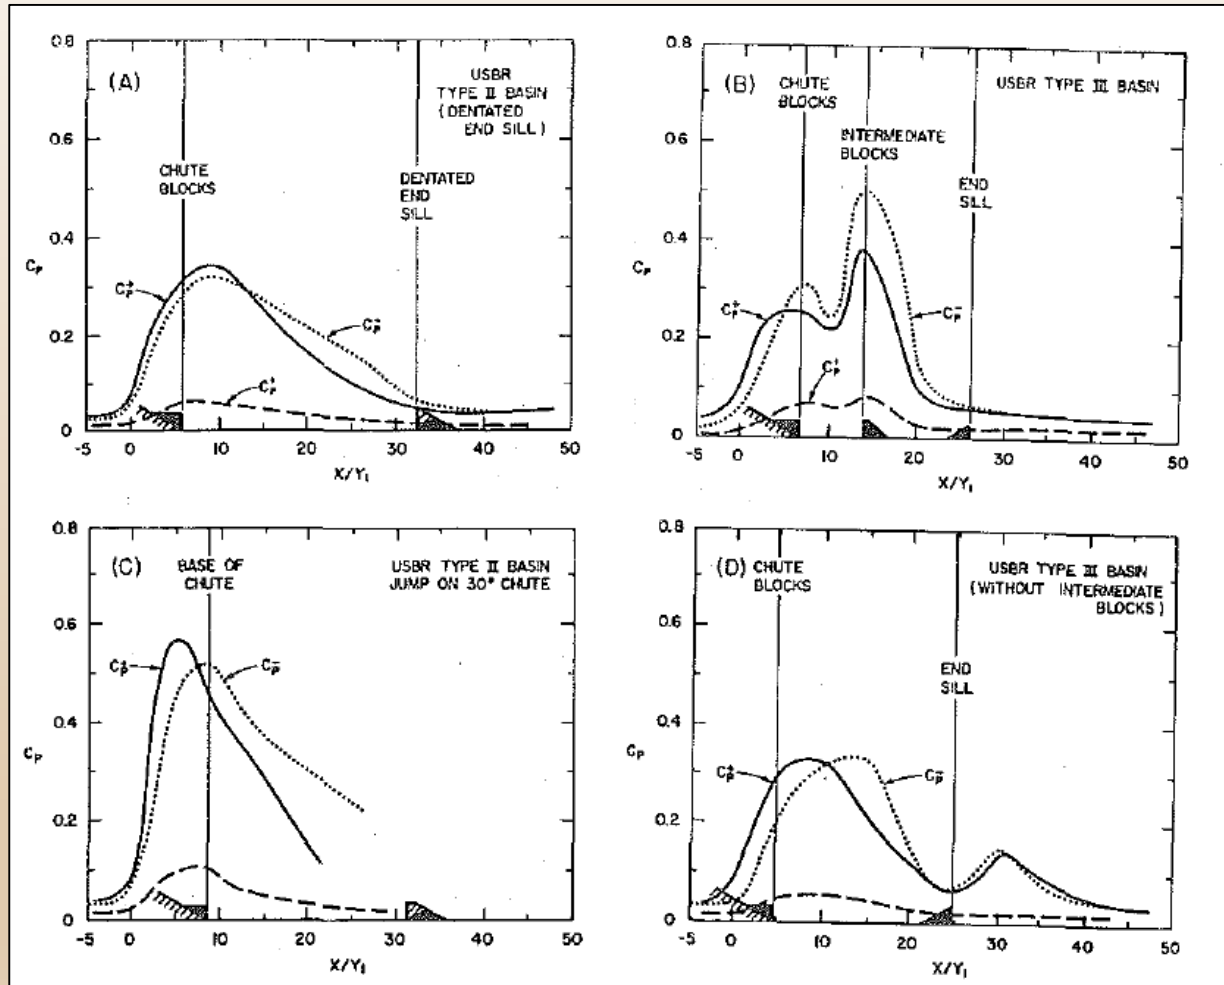
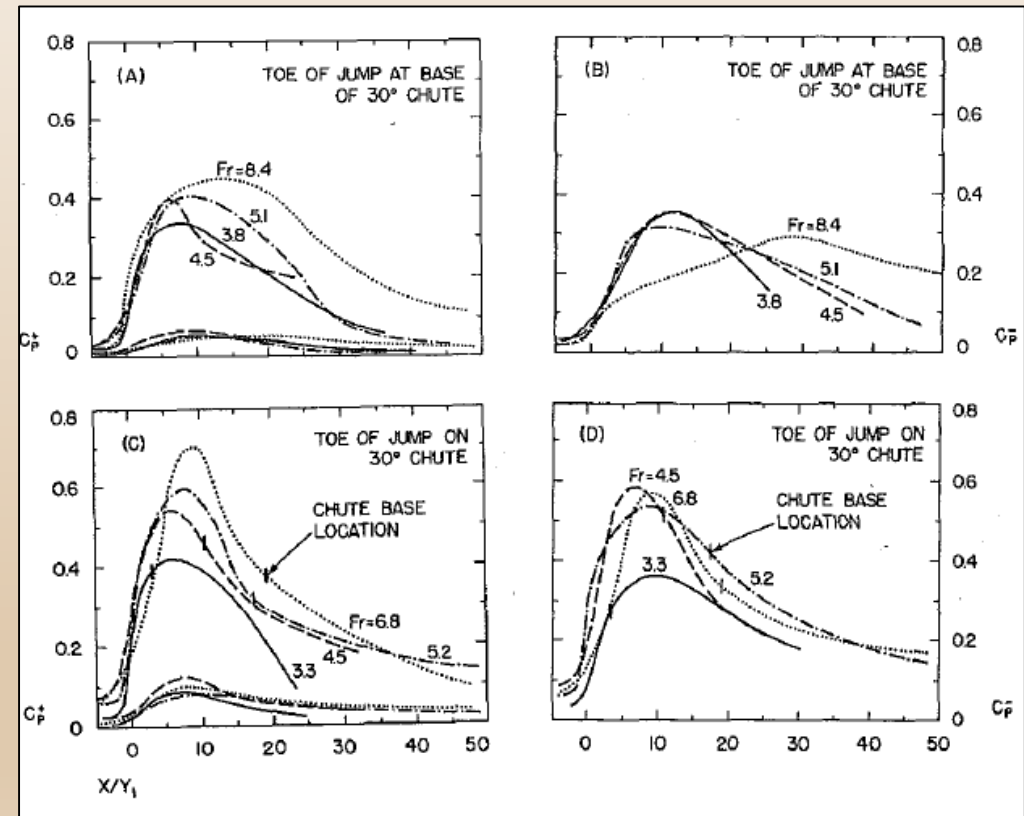
Analysis Methods (Pressure Fluctuation)

$$\Delta P = C_p^{+/-} * \frac{V^2}{2g}$$

Toso and Bowers (1988)
